**CERAMIC MATRIX COMPOSITE CHARACTERIZATION UNDER A GAS  
TURBINE COMBUSTION AND LOADING ENVIRONMENT**

THESIS

Dustin J. Bertrand, Captain, USAF

AFIT-ENY-14-M-08

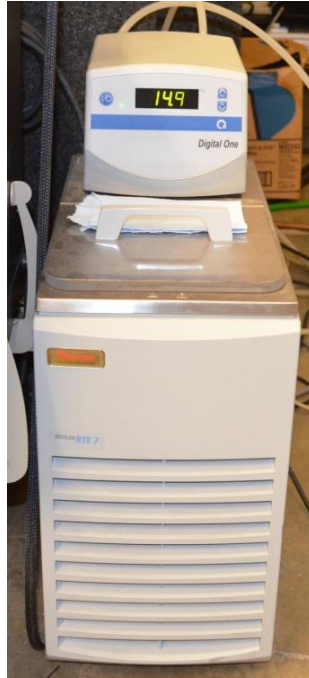
Each specimen was gripped with a pair of MTS 647 hydraulic wedge grips. The grip hydraulic pressure used for all specimens was 10 MPa. The flame used to create the combustion environment created a problem with keeping the MTS grips cool, since the flame was un-contained and heat was able to reach the grips. In order to keep the grips cool, an insulating and cooling approach was used. The first technique employed for cooling the grips was copper coils wrapped around each grip held in place by steel plates. Chilled water was run through the copper coils. The water was chilled using a NESLAB RTE 7 chiller (Figure 9) to a temperature of 10°C.

**Figure 9 - NESLAB RTE 7 Chiller**

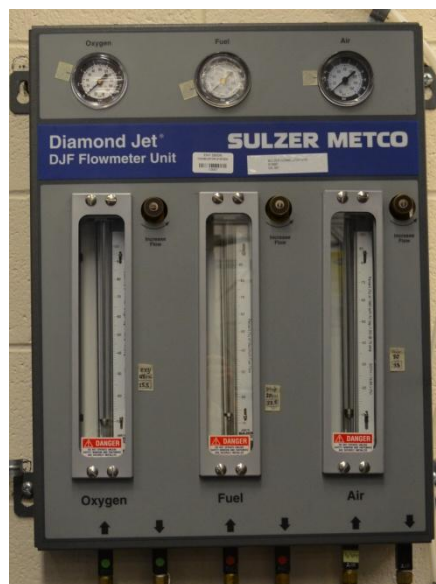
To control the gas flow of the flame gun, a DJF Diamond Jet Gas Flowmeter unit was used. The flowmeter unit consists of three rotameters to control oxygen, propane, and air flow independently. These three rotameters allow the accurate control of the amount of each gas being fed to the spray gun to control the flame being produced. Figure 13 shows the DJF gas flowmeter unit.

**Figure 13 - DJF Flowmeter Unit Used To Control Spray Gun**

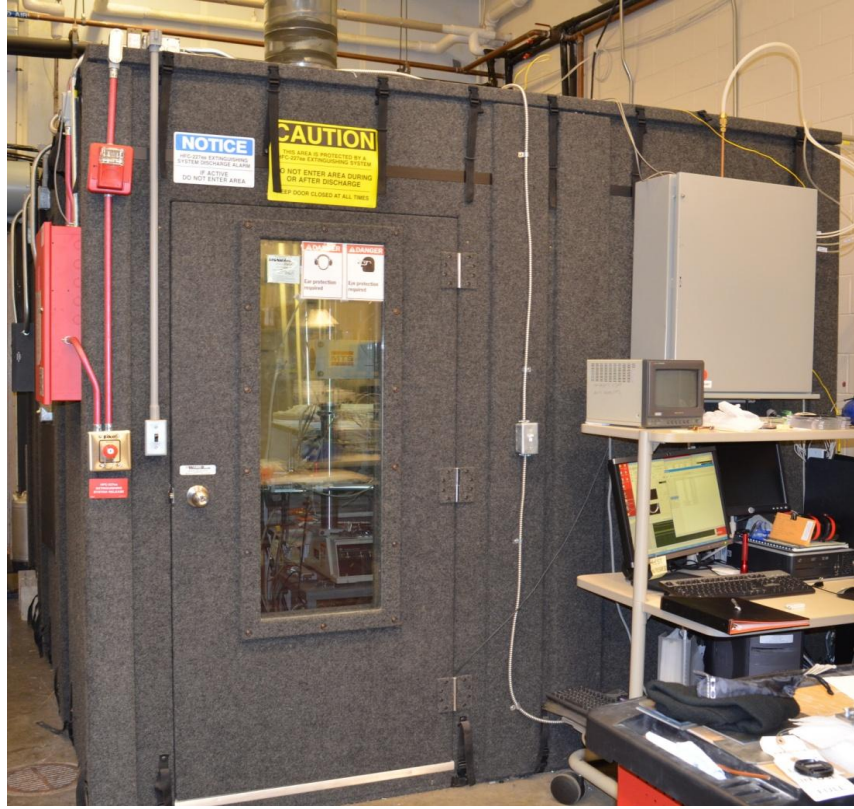
Since the HVOF spray gun produces a supersonic flame, there is a noise hazard associated with the operation of the gun. Fatigue testing required the gun to be run for long periods of time so it was necessary to contain the sound. To accomplish this, a WhisperRoom SE2000 series sound room was used to contain the MTS machine and HVOF spray gun. Exhaust ducts were added to the room to remove gas products and heat produced by the flame from the room. An HFC-227ea fire suppression system was also installed the room because of the fire hazard associated with an open flame. Figure 14 shows the whisper room.

**Figure 14 - Whisper Room Containing Burner Rig Test Setup**

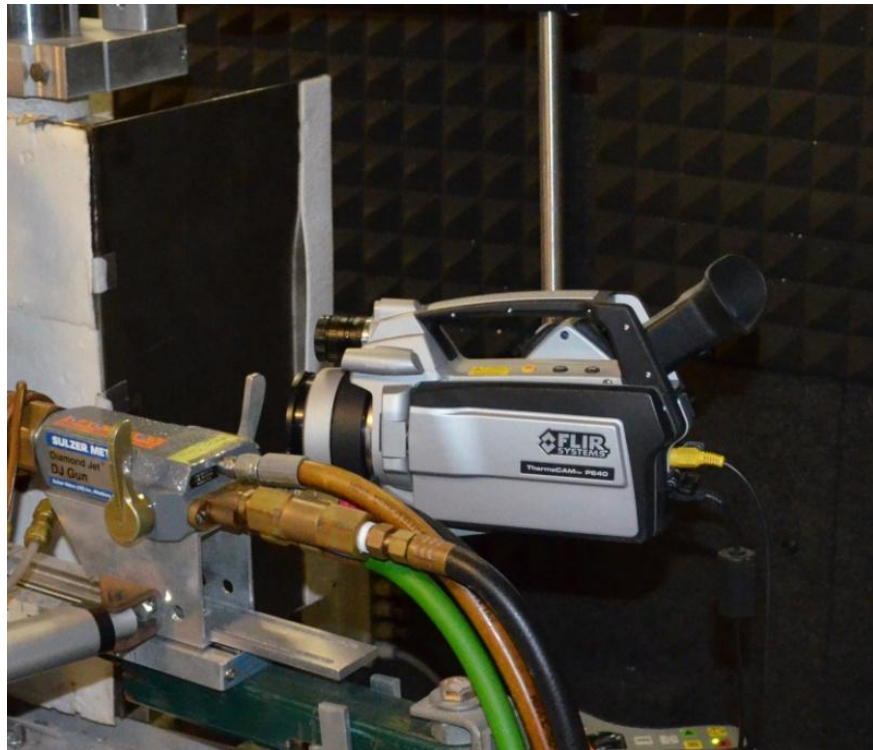
speed flame and high temperatures did not allow for the use of a thermocouple to measure temperature directly. To accomplish this, a Forward Looking Infrared (FLIR) system was employed. The FLIR camera system used for this research was a ThermaCAM P640 manufactured by FLIR Systems Inc. (Willsonville, OR). The FLIR camera was used to monitor the temperature of the front of the specimen. The ThermaCAM P640 has a 640x480 pixel infrared detector, with  $\pm 2\%$  accuracy. The camera is capable of measuring temperatures in a range from -40 to 2000°C. The detector also has a spectral range of 7.5 to 13  $\mu\text{m}$ , with a minimum focus distance of 0.3 m. The thermal sensitivity of the camera is 55mK at 30° C. Figure 1 shows the FLIR camera [5].

**Figure 16 - FLIR Camera In Mount**

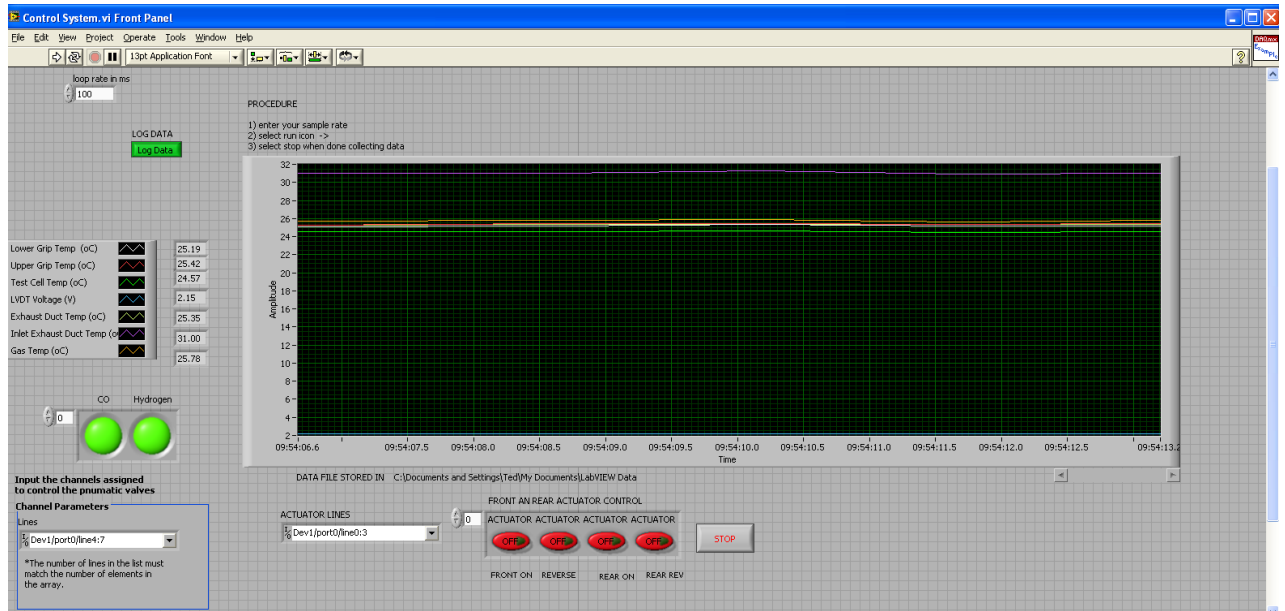
**Figure 23 - LabVIEW Software Display Before Start of Test**

The Zimmer LPG vaporizer was turned on first to gasify the liquid propane. The liquid propane and liquid oxygen tanks were then opened. The NESLAB chiller was then turned on to allow the MTS grips and the HVOF spray gun nozzle to cool to a temperature of 10°C at the start of testing. The FLIR camera was turned on, and the ambient temperature and humidity settings were adjusted to the values measured inside the whisper room. The two exhaust fans were turned on and the LabVIEW control system is started to begin recording temperature data and allow the compressed air valves for the oxygen and propane to open. Figure 23 shows the LabVIEW software display screen before the start of testing. The valve for the cooling air system was then opened.

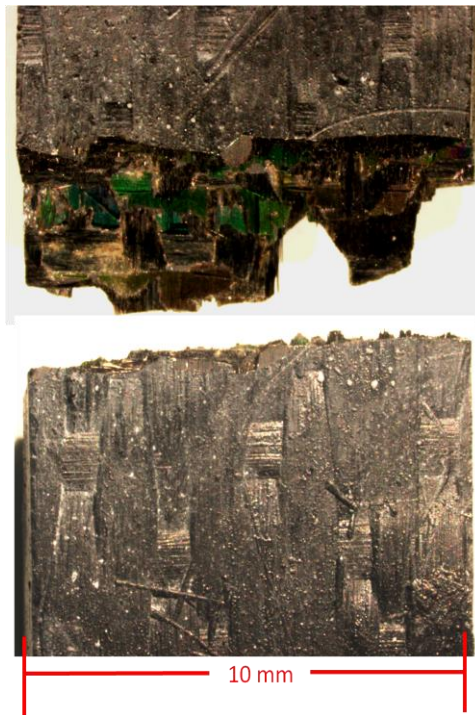
**Figure 64 - Flame Side of Specimen N82 After Fatigue Test With no Material Loss**

Figure 64 shows the area of fracture for specimen N82. This image is of the side facing the flame. This specimen did not show any noticeable signs of material loss as evident in the following figures.

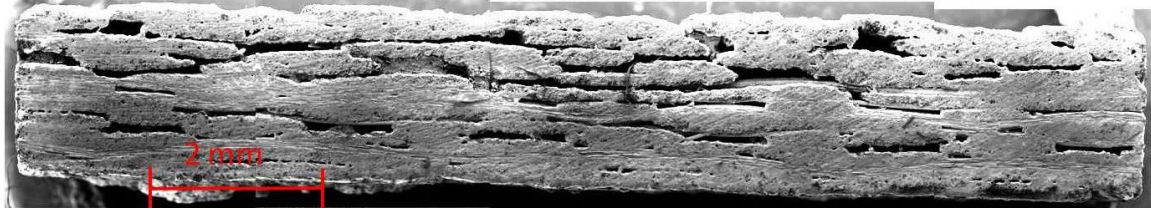
**Figure 73 - SEM Image of Un-tested Specimen**

Four specimens were selected to perform microstructural analysis on using images taken by the SEM as well as a specimen as fabricated. One specimen was chosen from each selected temperature and specimen N811 since it had the most loss of material. One side of the fracture surface was imaged in the SEM. Specimen N811 was also cut and polished as described in chapter 3.2.5 to observe any stovepiping or other phenomenon that may have traveled down the length of the specimen. Stovepiping is a phenomenon where gases from combustion travel down the length of the fibers of the CMC. Figure 73 and Figure 74 show SEM images of the cut surface of an un-tested specimen.
